# Manhole Inspection Summary

Manhole # S43KK\_032MH

**Location** Address: **REGESTER**

Cross Street: **LAFAYETTE**

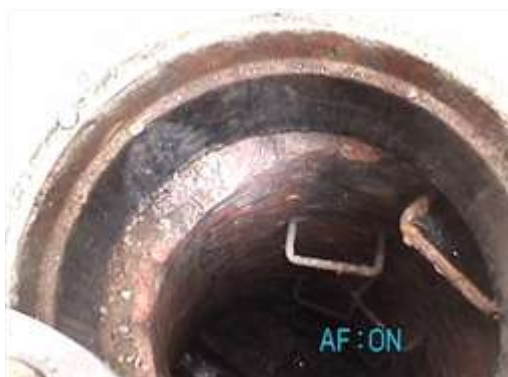
Defect 1

Infiltration: ☐ None ☒ **Joint** ☐ Cracks ☒ **Mortar** ☐ Roots ☐ Wall

Infiltration: ☐ None ☐ Joint ☐ Cracks ☐ Mortar ☐ Roots ☒ **Wall**

Infiltration

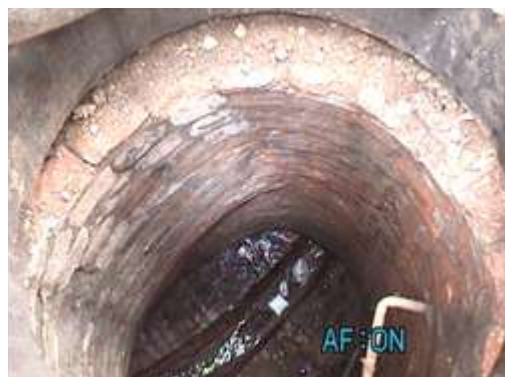
Defect 2

**Frame** Offset: **3** (in.) Condition: ☐ Sound ☐ Cracked ☒ **Leaks**

Frame leaks

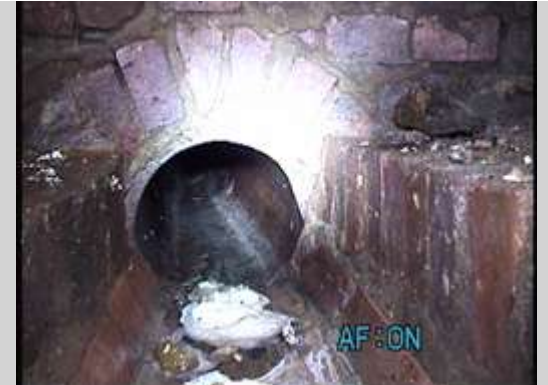
12 O'Clock Outflow

8 in. Circular Gravity Sewer  
Pipe Out @ 12 O'Clock

Pipe Height: **8.4** (in.) Rod and Bar (Angled)  
Pipe Material: **Clay** ☐ Pipe Lined  
Invert Depth: **10.40** (ft.) Flow Characteristics: **Fast**  
Deposits: ☒ None ☐ Mud ☐ Sludge ☐ Debris ☐ Grease  
Silt Depth: (in.) Deposits Extent:  
Infiltration: **None** Pipe Seal Cond: **Sound**

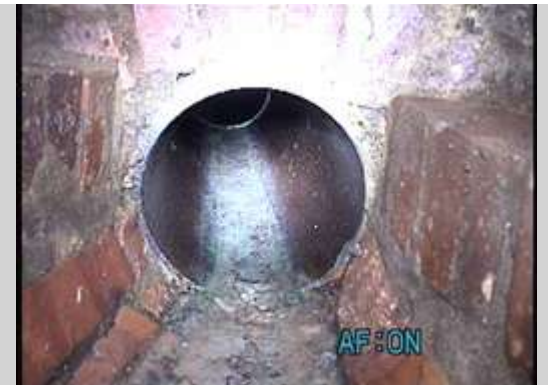
7 O'Clock Inflow

8 in. Circular Gravity Sewer  
Pipe In @ 7 O'Clock

Pipe Height: **8.4** (in.) Rod and Bar (Angled)  
Pipe Material: **Clay** ☐ Pipe Lined  
Invert Depth: **10.25** (ft.) Flow Characteristics: **Fast**  
Deposits: ☒ None ☐ Mud ☐ Sludge ☐ Debris ☐ Grease  
Silt Depth: (in.) Deposits Extent:  
Infiltration: **None** Pipe Seal Cond: **Sound**
